# **Effect of Aquifer Dumpflood on the Reservoir Scale Tendency and Subsurface Equipment Corrosion**

Abd Elaziz M. Salah Eldin  
Abu Dhabi Marine Operating Company ADMA-OPCO  
Abu Dhabi, United Arab Emirates  
Fax: 971026064771  
E-mail: aaziz2@adma.ae

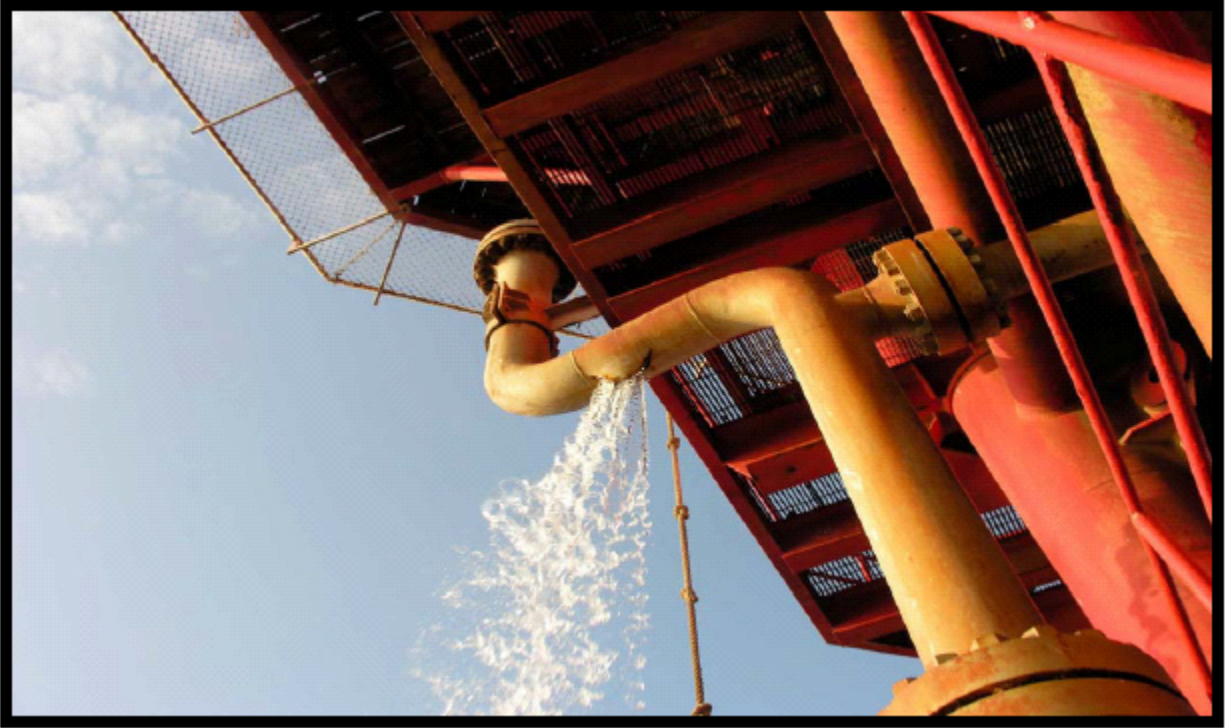
Lately, SRB active bacteria in non-flowing parts of the system was added to other possible causes which resulted in a recent rupture of 2300 psi operated 10” cross over at the complex (Figures 1-2).

Figure 1 – Rupture of 14" Water Injection Line at ZK-77

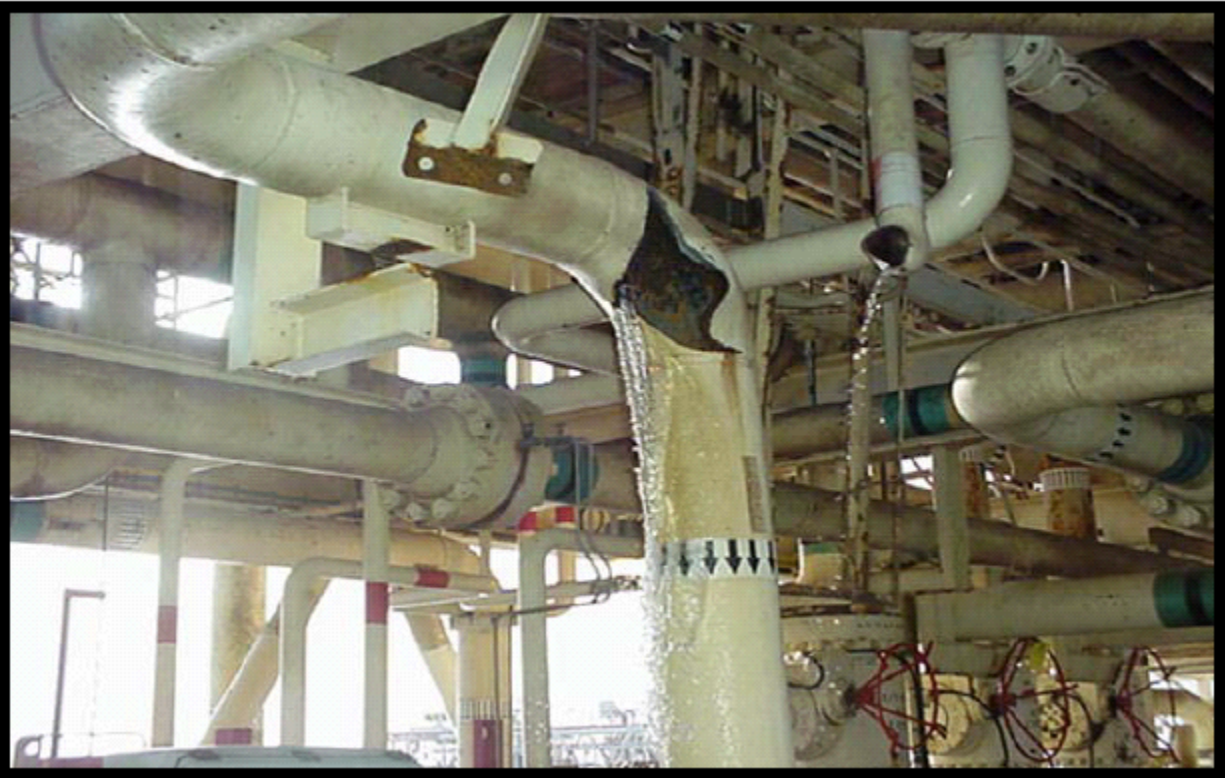
Figure 2 – Rupture of 10" Non-Flowing Crossover at the Water Injection Platform

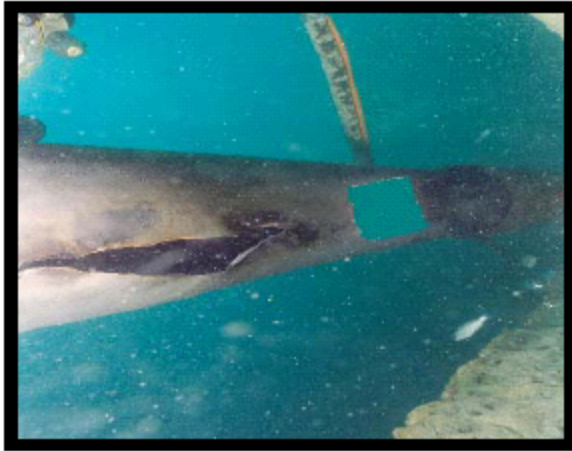
The subsea lines experienced seventeen (17) leakages up to the year 2003. Thorough investigation revealed that the corrosion is due to microbial corrosion by SRB. A remnant life assessment (RLA) study was conducted to assess the health of the network. The study revealed that at least half of the subsea pipeline network requires immediate replacement and other pipes are at a high risk of failure unless remedial actions are implemented to minimize the risk to an acceptable level. Accordingly, a comprehensive corrosion control scheme was established which is mainly based on mechanically cleaning the entire network.

Figure 3 – Corrosion Damage at 6 O'clock Position  
Due to SRB Activity

- Provide all new replacement water injection lines with permanent pigging facilities to allow cleaning of all lines using conventional bi-directional pigs, once every 3 months.
- Install side streams at all remote water injection towers to monitor SRB bacterial growth.
- Upgrade the corrosion monitoring system to include all water injection towers.
- Carry out residual biocide measurements at selective remote towers, once every 6 months.
- Improve the SRB sampling and measurement procedures to allow most accurate methods to be used.
- Carry out an audit by a third party to review ADMA-OPCO current microbial mitigation measures and control strategy and identify gaps.

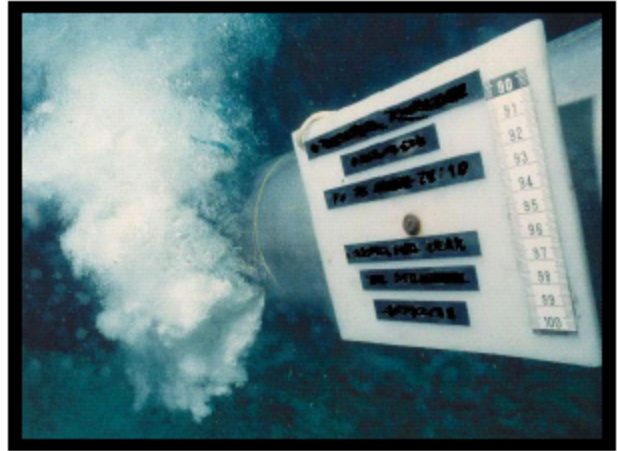
Figure 4

The scheme was fully implemented and the result was that no more leaks were recorded in the subsea network since 2003 (Figures 3-5). Nine pipelines were already replaced with new ones equipped with a permanent routine pigging facility. Side streams were installed to allow measuring sessile bacteria enumeration on a continuous basis. Residual biocide measurements were also established to ensure that the optimum kill dose is injected. Intelligent pigging of selective lines is ongoing to assure pipelines fitness for service and to validate the RLA prediction model.

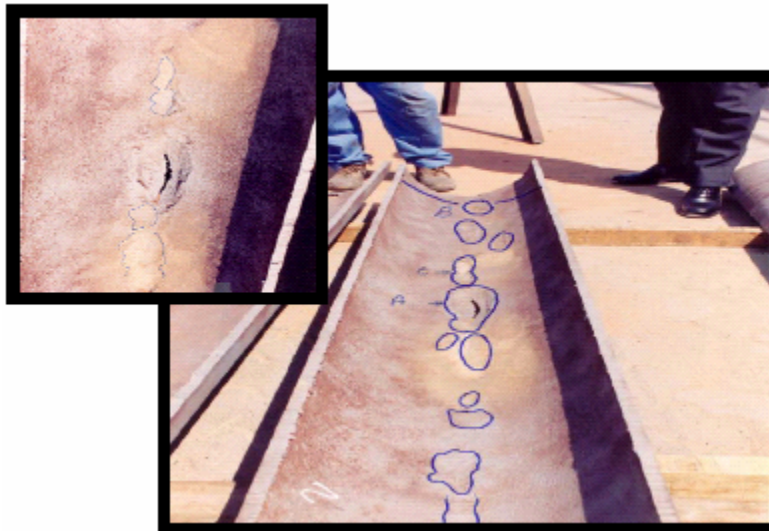
Figure 5 – Inside of the Failed Pipe  
Note the interconnected pits

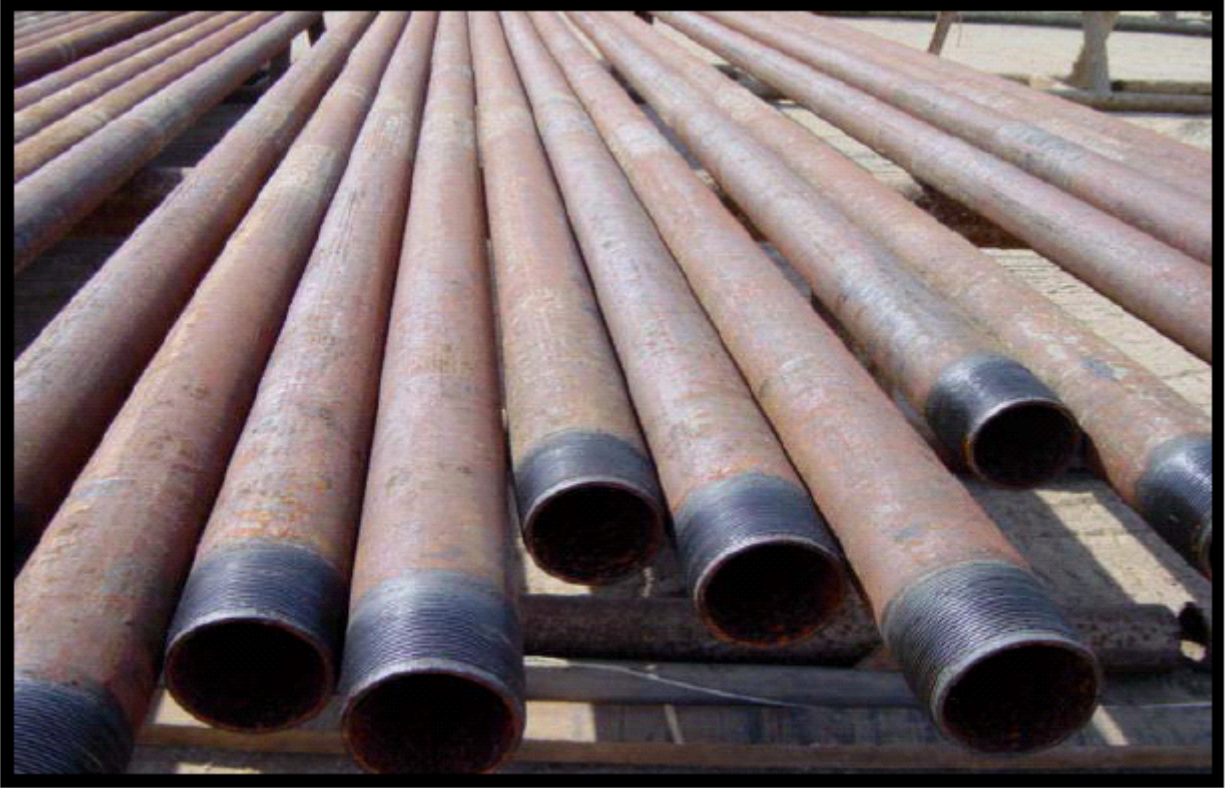
Figure 6 – Tubular Goods Recovered from ZK-234 after Twenty Years of Service

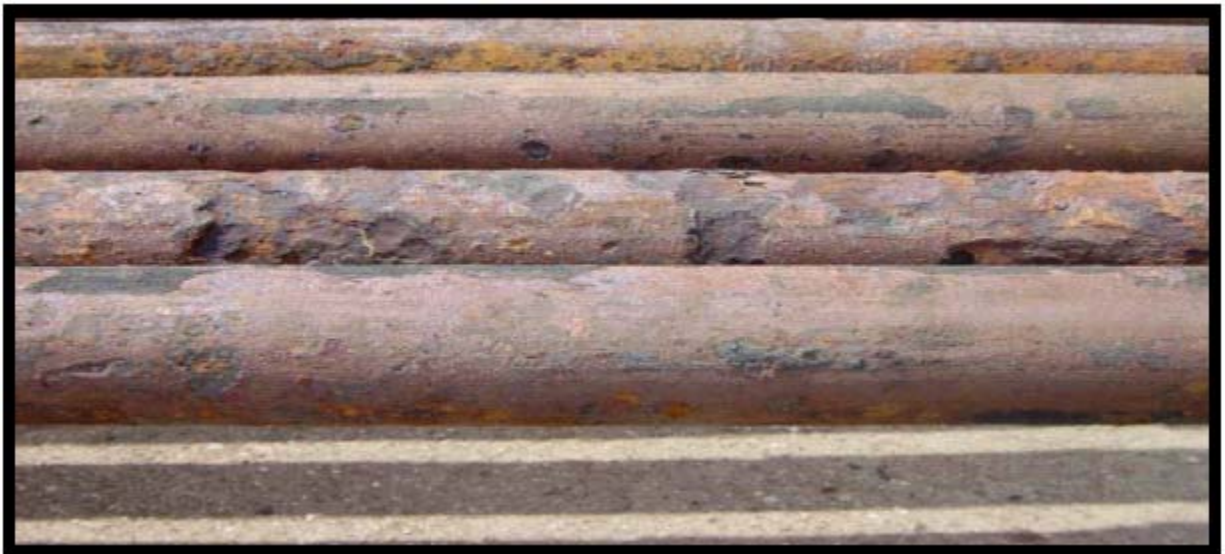
The recovered completion from both wells was inspected during the year 2004. The inspection reports clearly described the recovered completions being free from corrosion damage and scale build up, both externally and internally. MVRT corrosion log was run in the 9 5/8” casing of ZK 234 and ZK- 202 in November 2004. The survey revealed that the casing is as good as the tubing and no corrosion damage internally or externally (Figures 7-8).

Figure 7 – Corroded Completion Recovered from ZK-144 Short String Against the Aquifer

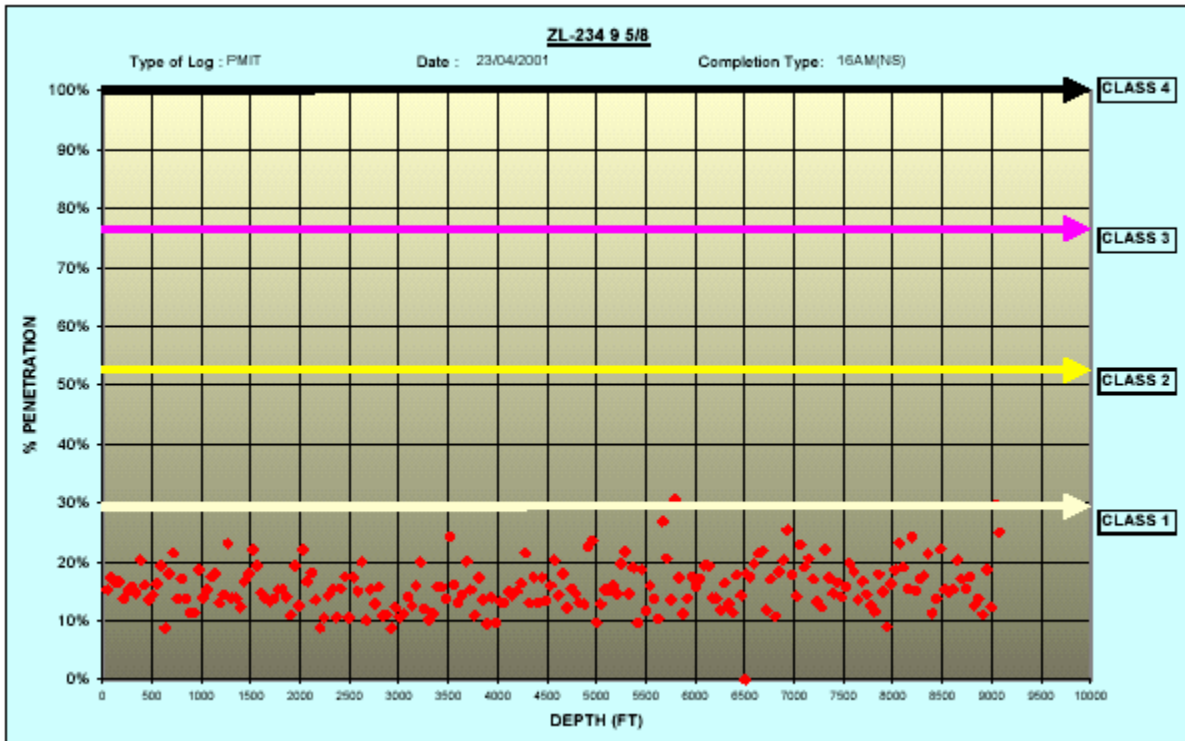
Figure 8 – ZK-234 MVRT Log in 9-5/8" Casing

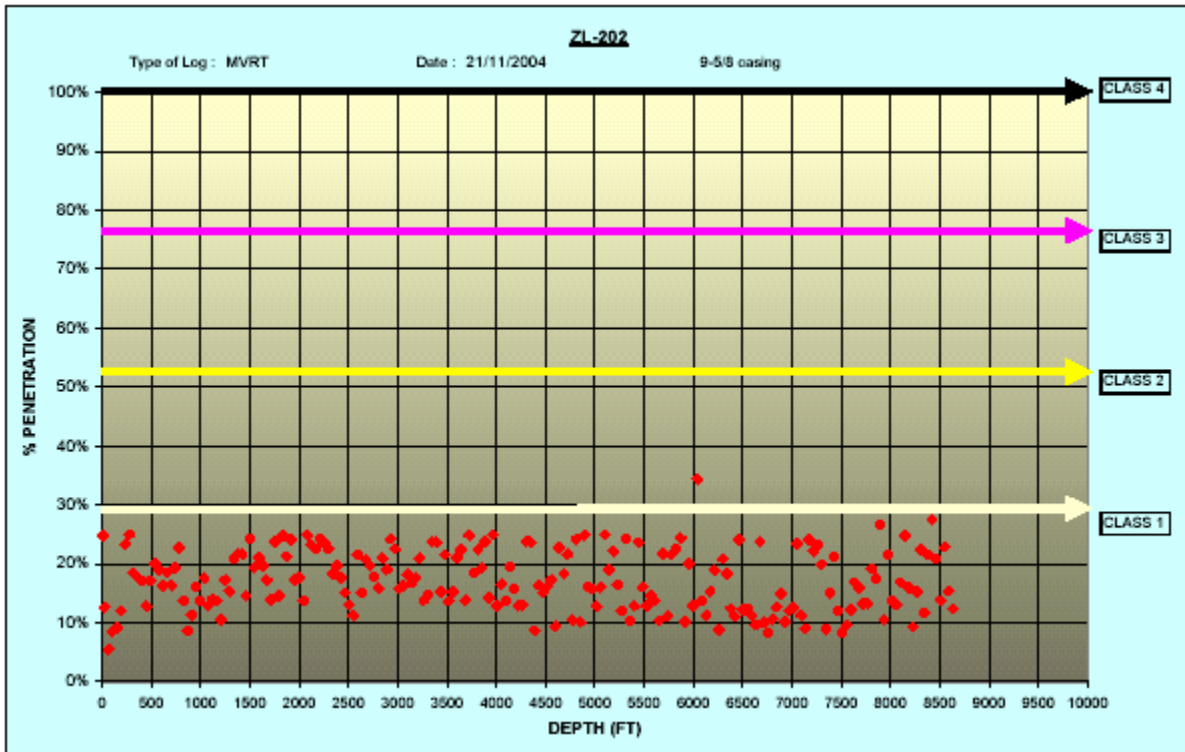
Figure 9 – ZK-202 MVRT Log in 9-5/8" Casing

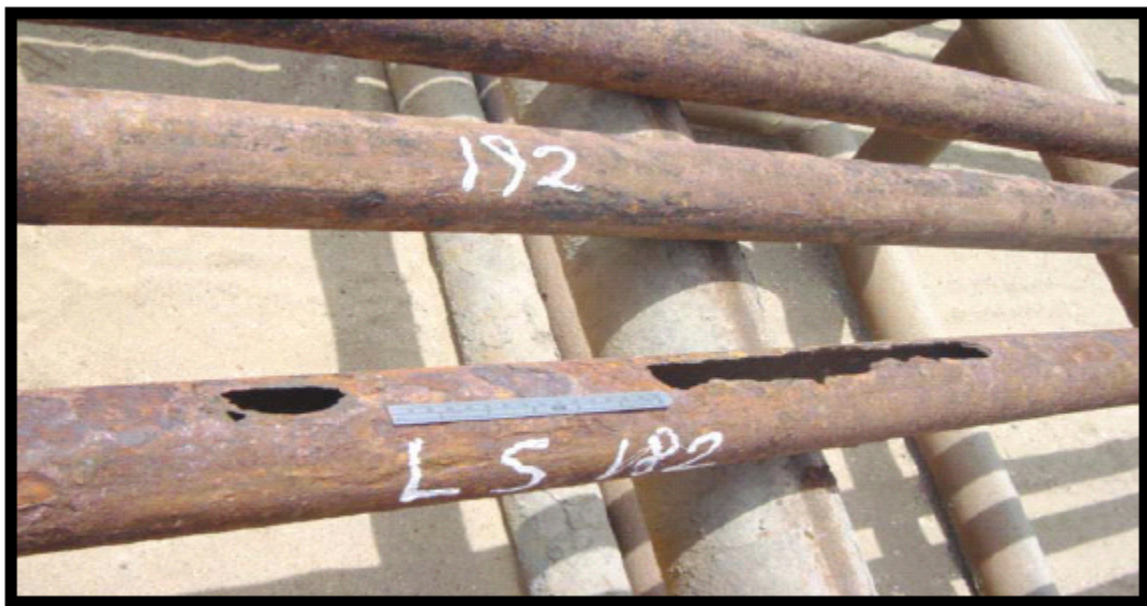
- Severe preferential corrosion attack was noted on the coupling characterised by an **ARC** or **V** shaped metal wastage on the box and collar (Figure 11). The metal loss was noted to be on one side along the entire length of the strings, which is the side in contact with the casing. This may lead to the belief that the casing some how acts as a cathode relative to the tubing which is the anode site in this galvanic corrosion cell.

Figure 11 – Interconnected Corrosion Holes all Aligned to One Side in Contact with the Casing

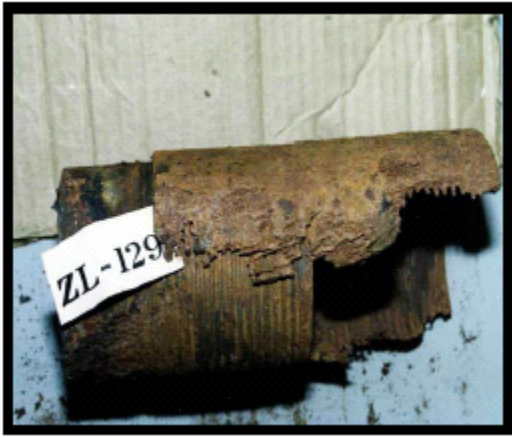
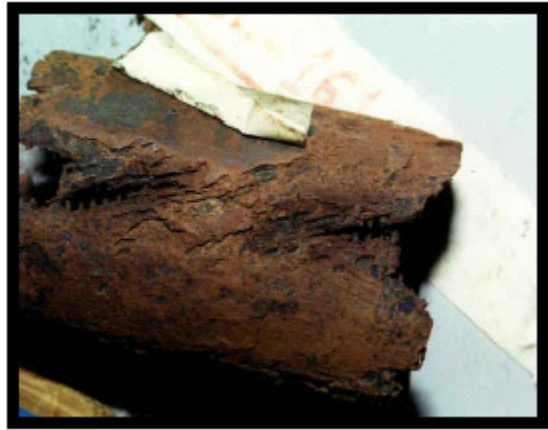
Thorough review of all possible corrosion damages which can lead to such corrosion make us to believe that subsurface equipment corrosion is simply due to initiation of galvanic cell between the casing (Cathodic site) and the tubing (Anodic site). The V shaped metal wastage on the tubing box of every single joint of the completion strengthened this argument (Figure 12).

Figure 12 – Note the V Shaped Corrosion Damage which is Common on all Completions and in Every Joint

- Seal aquifer zones using permanent 7" tie back liner extended across the entire aquifer zone.
- Although SRB is not the principal cause for the corrosion damage of the water injection wells subsurface equipments, it may on long term, result in uncontrolled reservoir souring. A full scale Microbiological study shall commence and address mitigation measures to reduce potential reservoir souring.

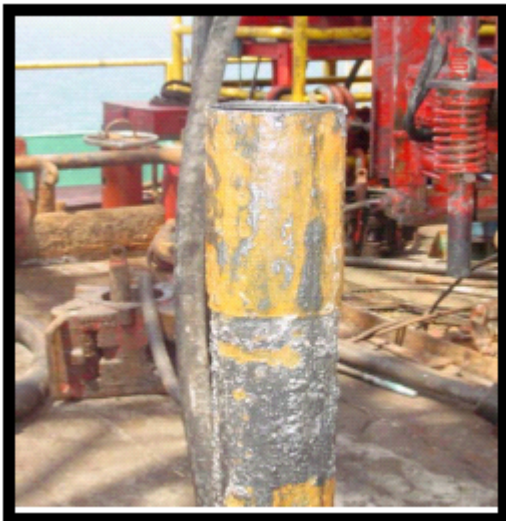
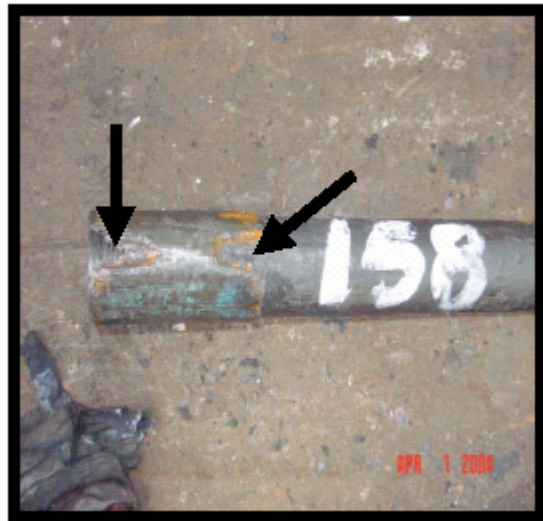
- Injection sea water and Simsima/Umm Er-Radhuma aquifer are not compatible. A very high affinity to precipitate Calcium Sulphate scales ( $\text{CaSO}_4$ ) exists. This was physically experienced in US 55. Aquifer water has, however, a self scaling tendency to precipitate Calcium Carbonate scales ( $\text{CaCO}_3$ ) as it is subjected to the cooling effect of the injection water and the loss of  $\text{CO}_2$  gas which is assumed to be consumed in the corrosion process (Figure 13).

Figure 13 – V Shaped Damage to the Tubing Box in ZK-152 – see arrows

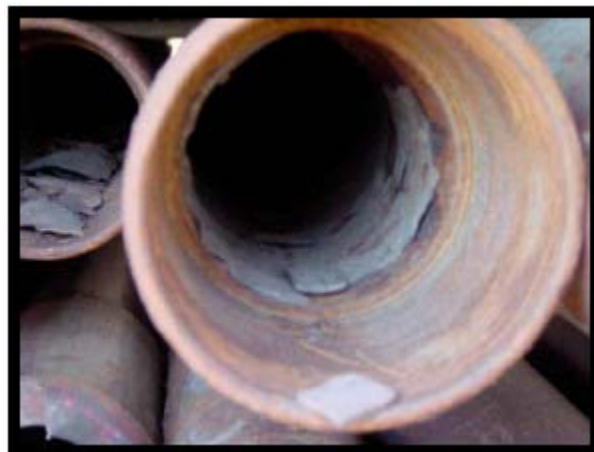
Figure 14 – Iron Oxides & Calcium Carbonate Scale Deposition on the Internal Tubing Surface of ZK-152
