**Integrity Management of the Water Injection
Networks in ADMA-OPCO
“A Historical Review of Service Life Events
and its Contribution to the
Experienced Network Failure”**

Abd El Aziz M. Salah
Abu Dhabi Marine Operating Company
Abu Dhabi – United Arab Emirates
E-mail: Aaziz2@adma.co

ZK 145 to ZK 168, 14” water injection line failure was considered as a typical example to investigate the mode of failure and identify the root causes.

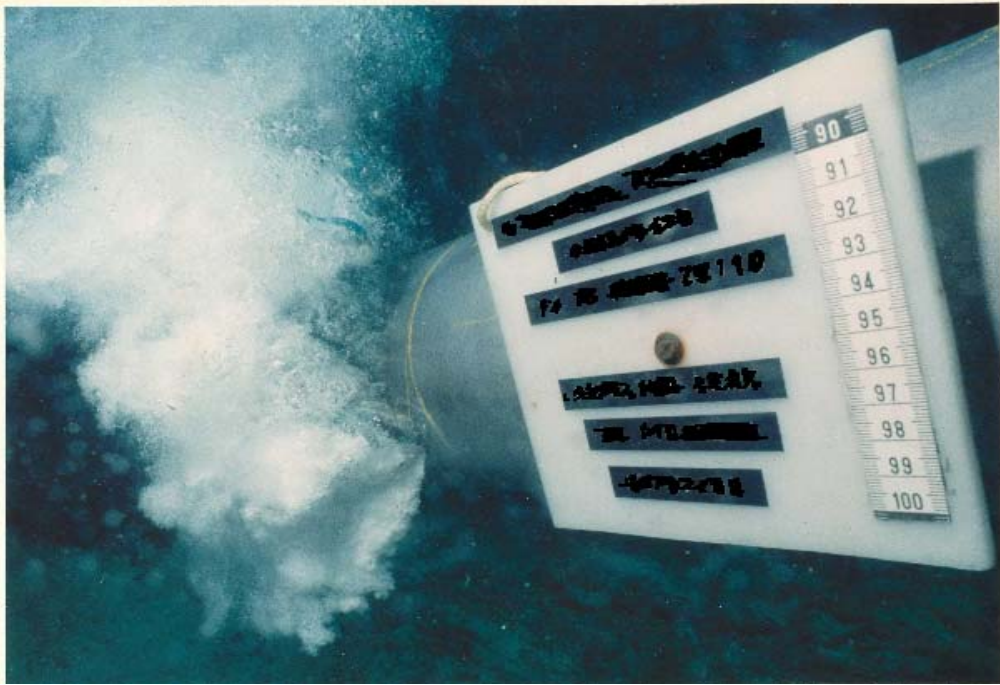
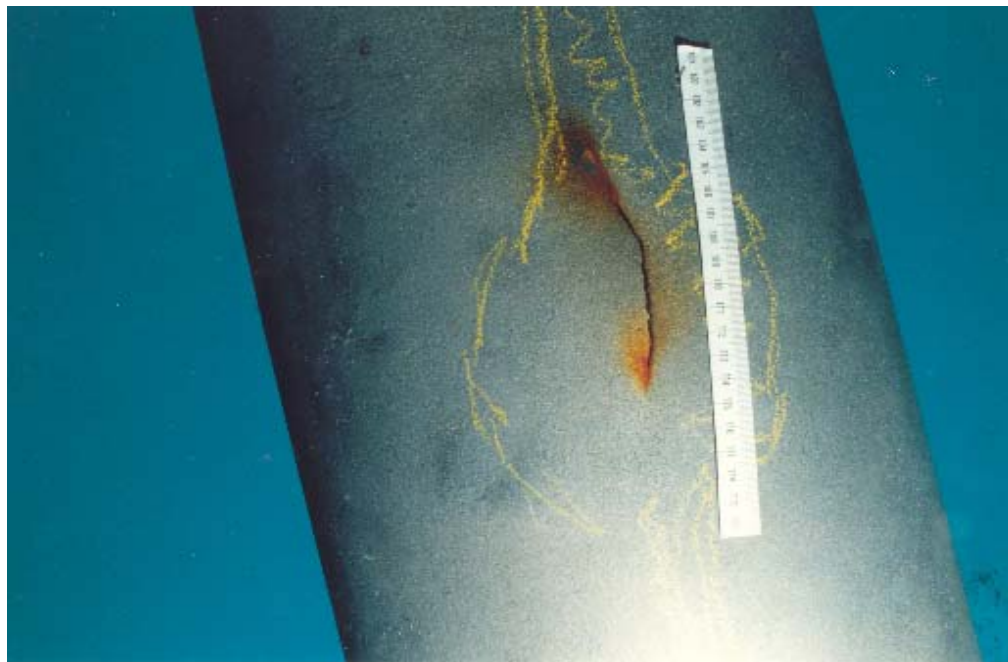
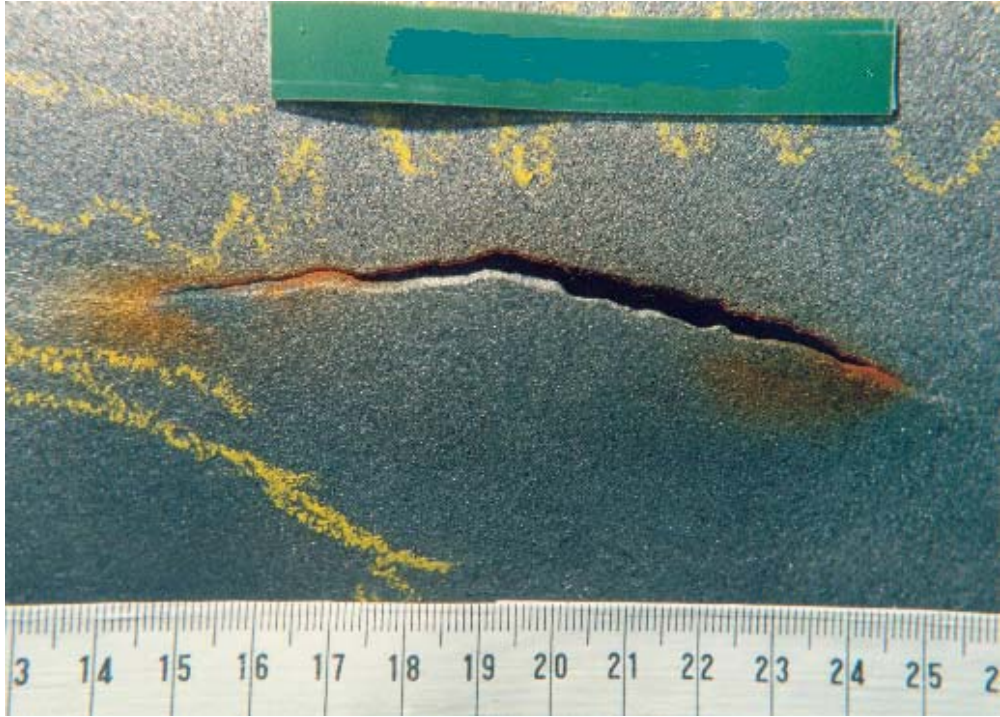
Figure 3 - Joint No. 155 from ZK 168

The leak was located at the 6 o'clock position and resulted from a longitudinal rupture which extended 120 mm long by 50 mm wide. The flowline appeared to have suffered permanent deformation before bursting as indicated by an observed bulge on one of the rupture edges (Figure 3, 4 & 5).

Manual U.T. inspection revealed a band of pitting corrosion 540 mm long and 80 mm wide. The minimum thickness within this band was reported to be 8 mm but as low as 5 mm adjacent to the rupture edges.

A leak clamp was installed.

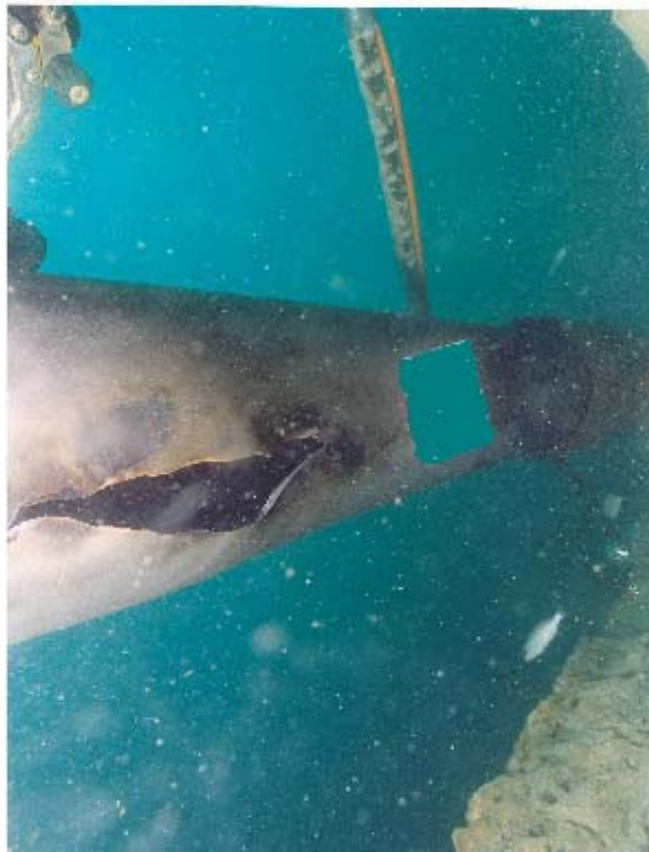
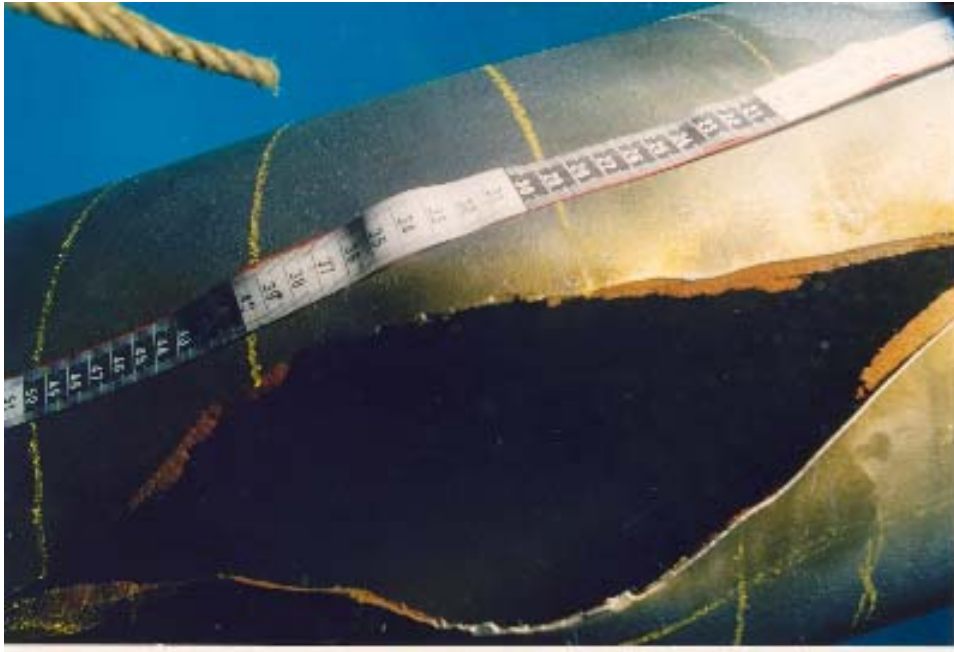
Figure 6 - Field Joint No. 451 from ZK168

The leak located at the 6 o'clock position 40 mm from the weld (toward ZK 145) resulted from a longitudinal rupture extended 370 mm long and 45 mm wide. Circumference measurement of the sound area was found to be 1120 mm compared to 1163 mm at the rupture area which indicated that the pipe has been bulged at the location of the burst (Figures 6 & 7).

Sonomatic inspection revealed some localized corrosion at the 6 o'clock position with clusters of pits measured to be up to 5 mm deep.

Repair clamp was installed on 2nd August 1992 and the line was satisfactorily hydrotested. However, the clamp was later retrieved and installed on other leaking locations on 14" ZK 168 to ZK 156. Reclamping of joint 451 was satisfactorily recompleted in April 1998.

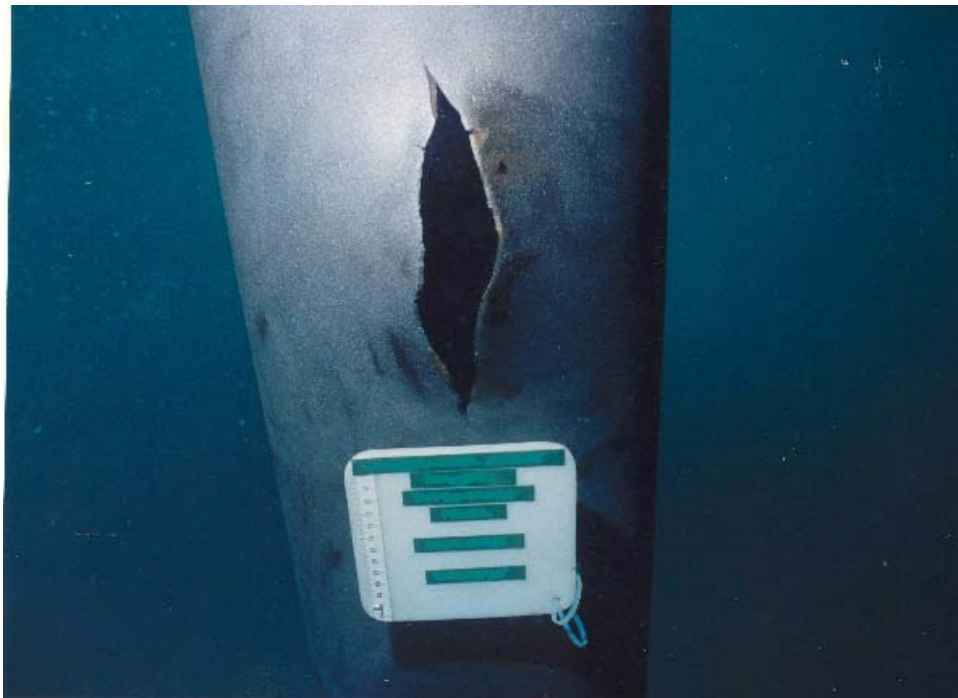
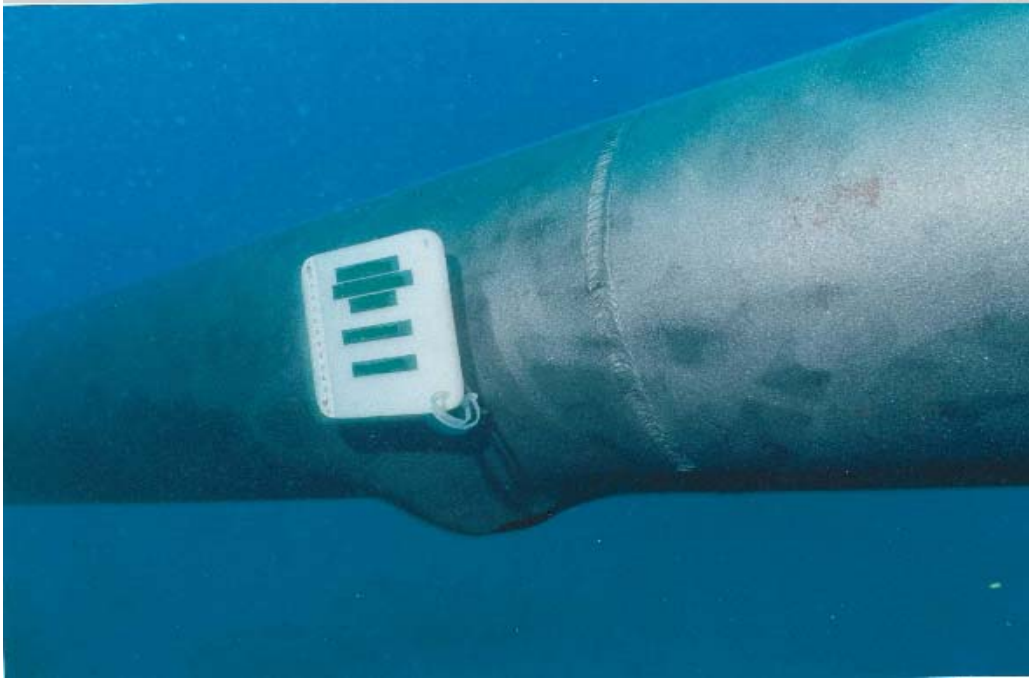
Figure 8 - Field Joint No. 301 from ZK 168

The leak was located at the 6 o'clock position 740 mm from the weld (toward Zakum 145) of joint 309 from ZK 168 resulted from a longitudinal rupture 340 mm long and 50 mm wide. It was evident that the flowline had suffered permanent deformation in the vicinity of the crack (bulging) which indicated that the line had reached its maximum operating pressure limit before bursting (Figures 8 & 9).

In addition to the rupture area a total of 13 spots were identified to be pitted with an average depth of 5 - 6 mm, all located at the 6 o'clock position. No Sonomatic survey was carried out at this location.

A standard leak clamp was installed in April 1998 and the pipeline was satisfactorily hydrotested at the maximum operating pressure.

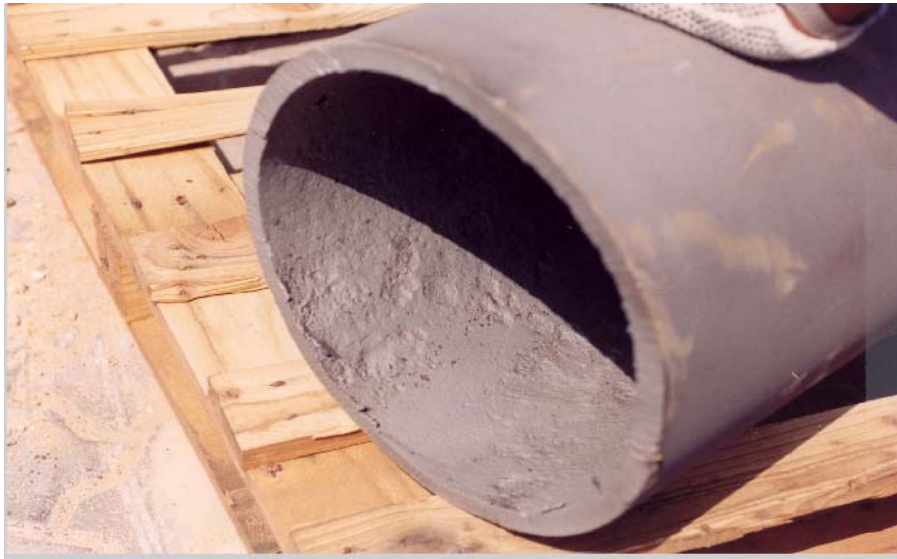
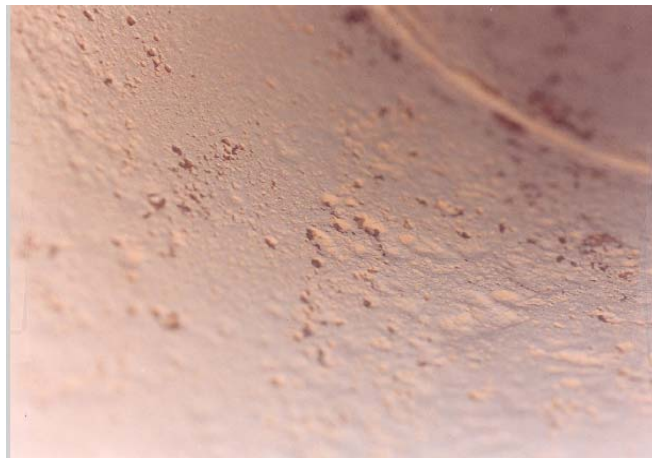
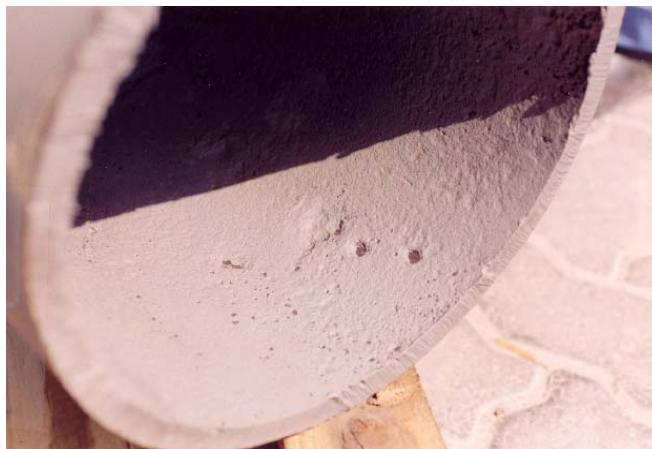
The four pieces showed numerous pits scattered throughout the entire internal surface of the pipe sections. The size of the pits ranged from 1 to 3 mm in depth and 2 to 8 mm in diameter. Figures 10 through 12 clearly show the pits size and distribution. Light scales of iron oxide/iron sulphide were evident and were found to be strongly adhered to the surface at a nominal thickness of 1 mm.

It is clear from the morphology and the distribution of the pits that they resulted from oxygen ingress into the system (Oxygen Induced Corrosion). The calculated average corrosion rate based on 20 years service is 0.15 mm/year.

The predominant corrosion mechanism is considered to be oxygen ingress, however, SRB may have contributed to the corrosion process at the 6 o'clock position. Based upon this corrosion rate the total expected service life of the line could come up to 60 years.

**Figure 12 - Riser Tubeturn
Oxygen Induced Corrosion & SRB Pits at 6 o'clock position**

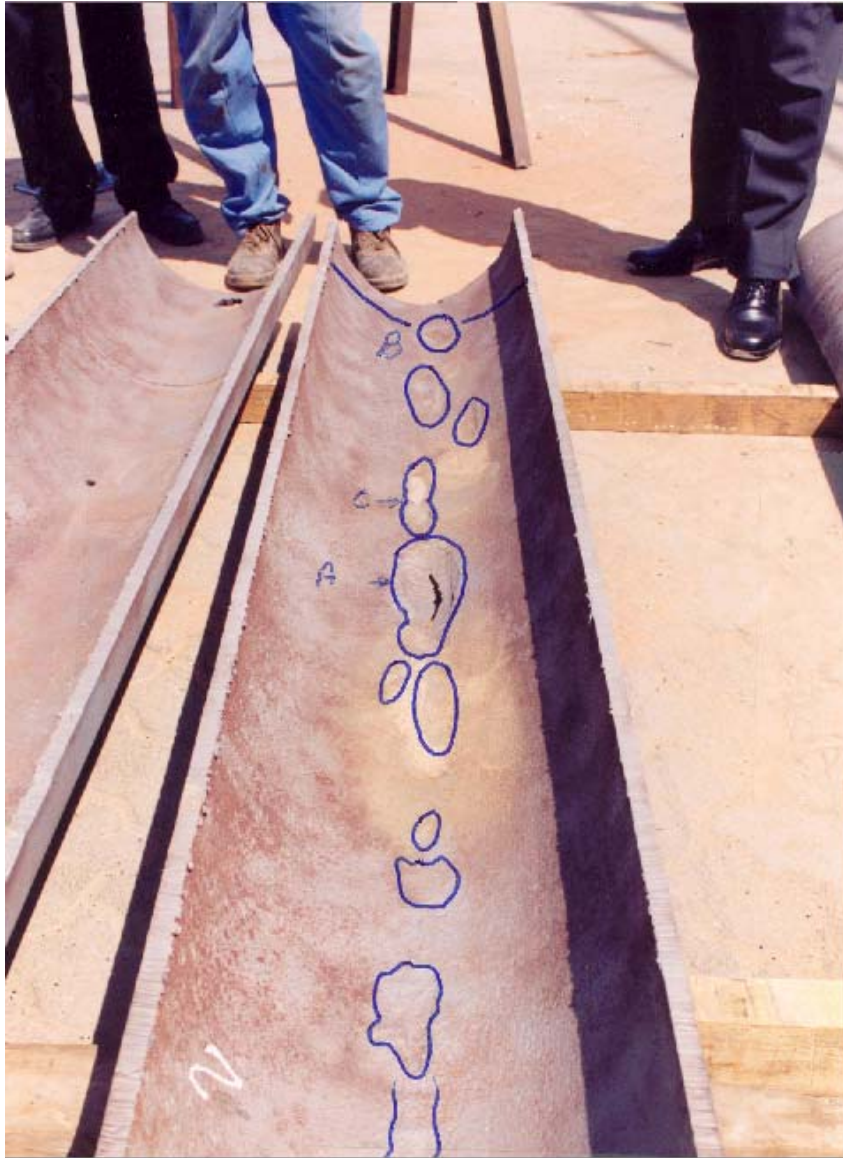
The absence of any other significant corrosion damage (apart from the 6 o'clock position) suggested that oxygen induced corrosion has little contribution to the corrosion process and evidently confirmed that Microbial Induced Corrosion is the prime cause of failure.

**Figure 13 - Failed pipe section recovered with leak clamp
Interconnected Corrosion Pits at 6 o'clock position
Max. thickness at burst location 2 mm**

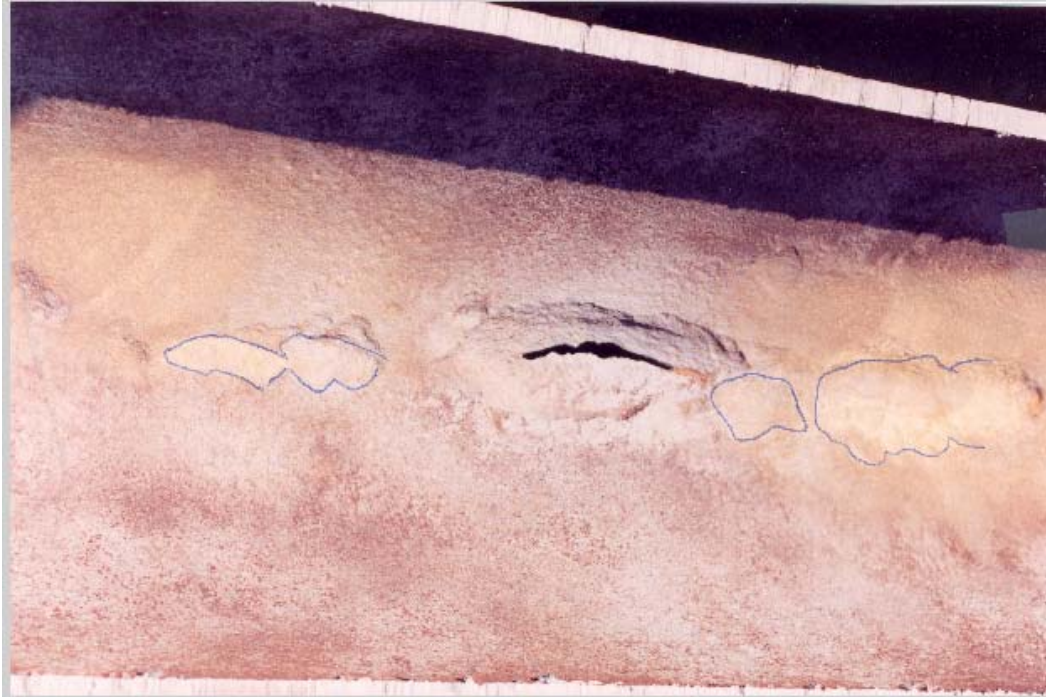
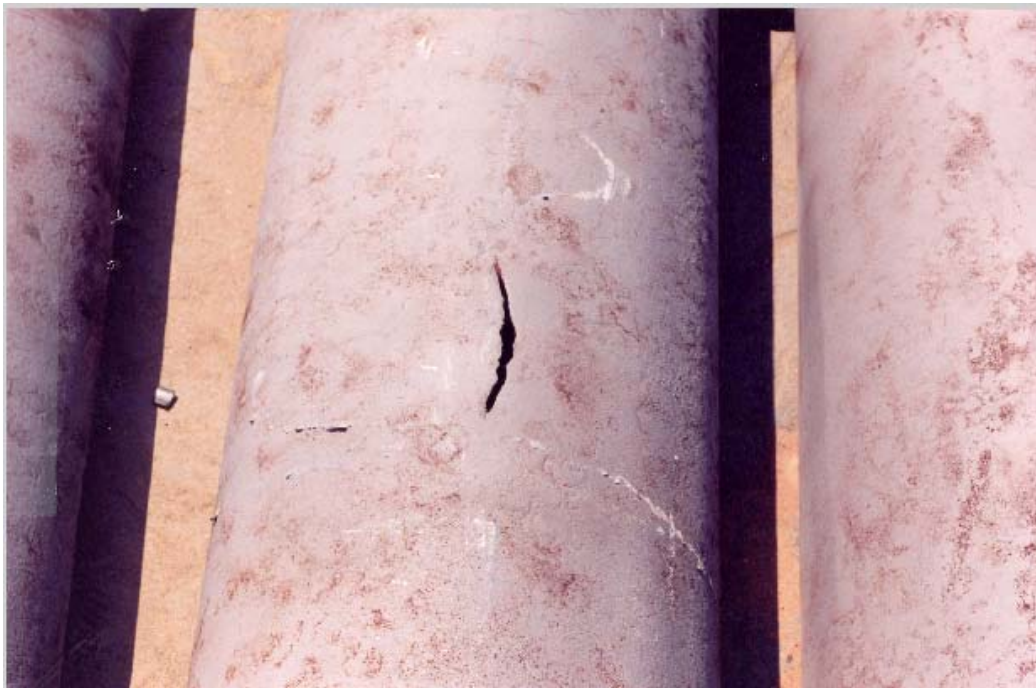
The defect geometry of the corrosion profile indicated by the Sonomatic survey provided excellent correlation with visual appearance of the retrieved section.

Figure 14 - Internal View

Figure 15 - External View

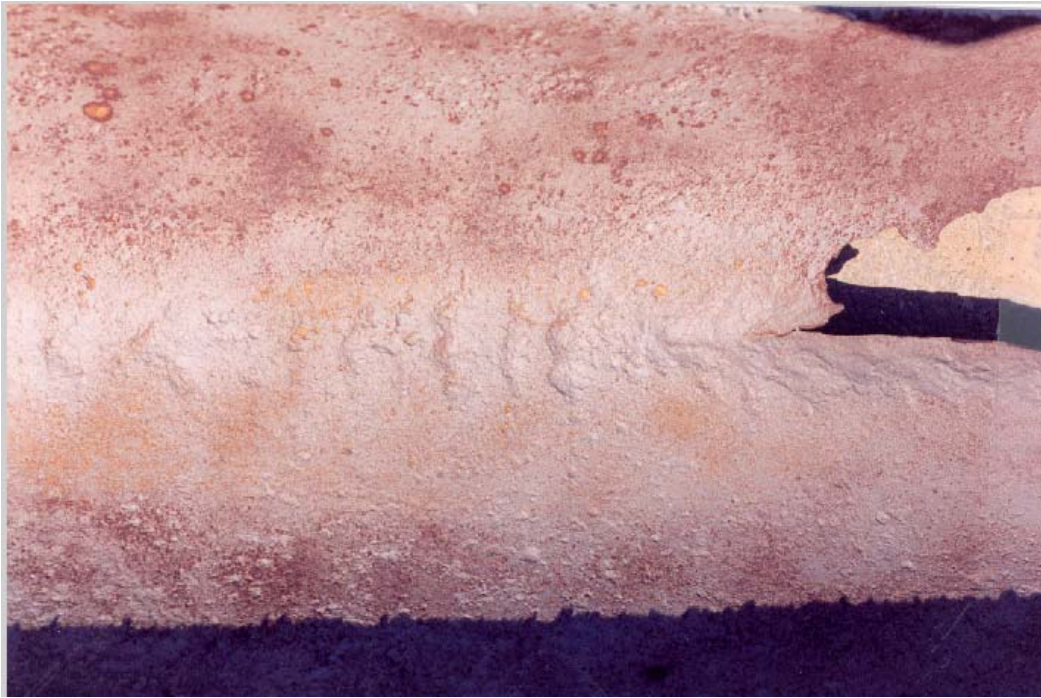
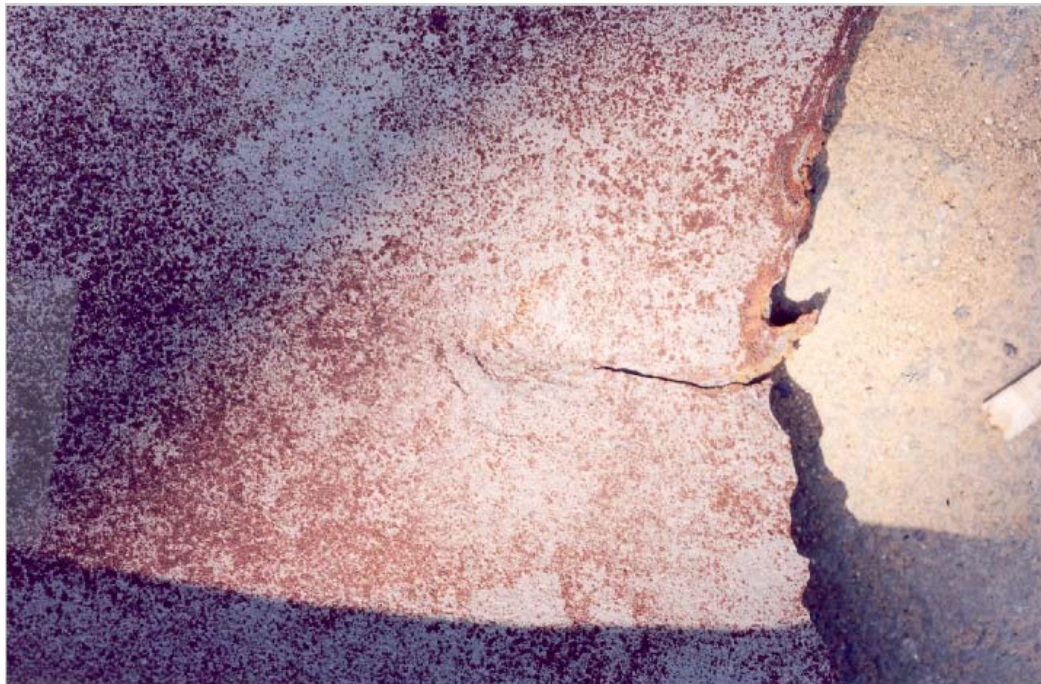
It is obvious from the photos that the area of rupture was trimmed off to allow leak clamp installation.

Figure 16 - Failed Joints recovered with Leak Clamp

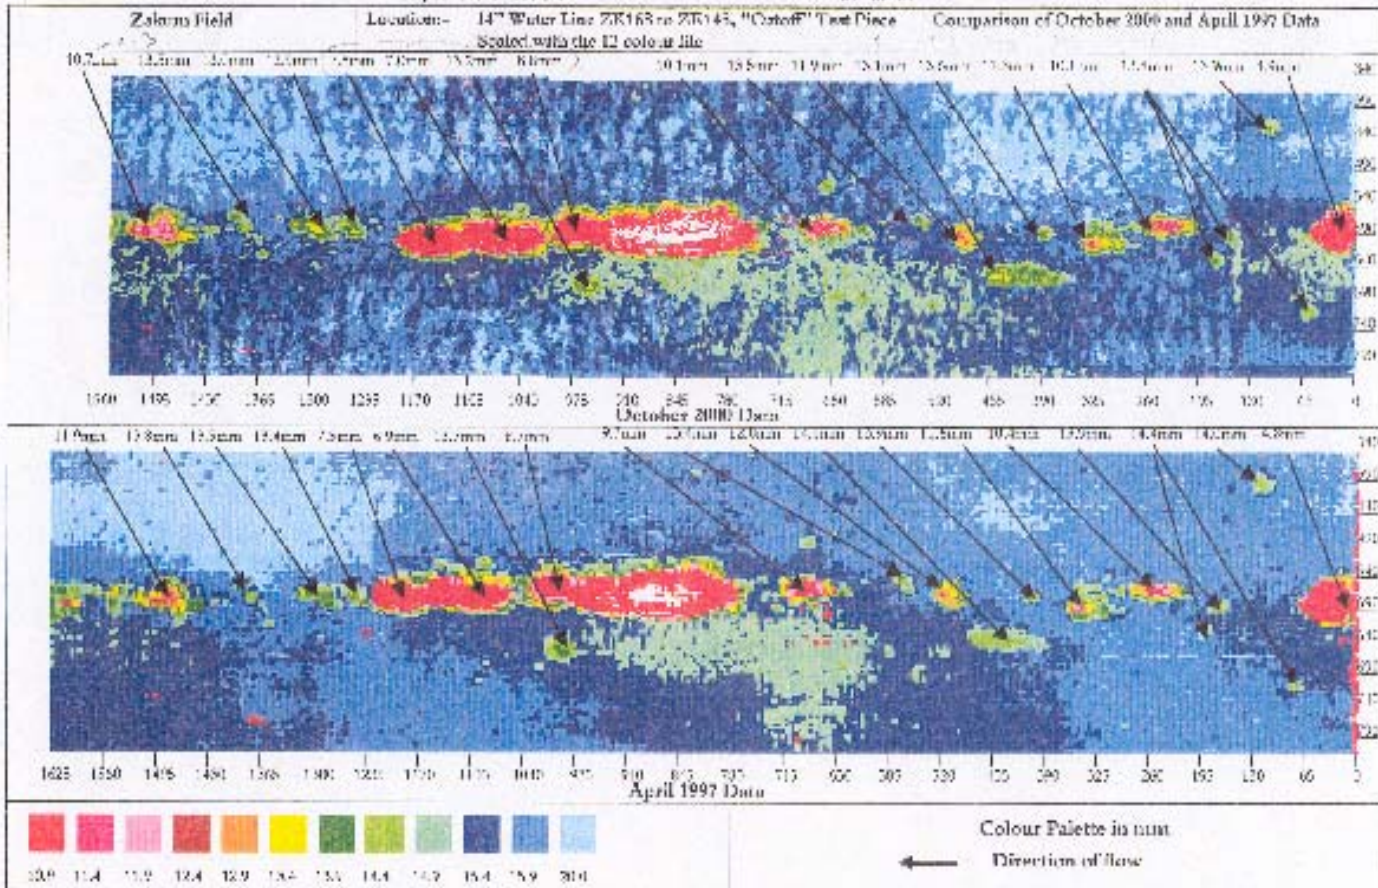
The cut-off joint recovered with the leak clamp was rescanned in October 2000 to validate earlier results and to measure the corrosion rate during the time period from the first scan and the line decommissioning. Figure 18 combines the two scans together for reference.

Further Sonomatic scan was carried out in October 2000 on the cut-off piece of the recovered joint which indicated a wall thickness loss measured since the previous scan in the range of 0.1 to 0.5 mm. The time period where the line was actually in service between the two scans is 32 months (April 1997 till December 1999) which implies an overall average corrosion rate of 0.1 mm/year.

This average corrosion rate although high on its absolute magnitude is, however, very much less than the overall average calculated at the burst location. The reduced corrosion rate was most likely attributed to the fact that the line was mechanically cleaned just after the first leak (1997). The mechanical cleaning would have removed or reduced the established biofilm allowing the biocide treatment regime to be effective, thereby reducing the corrosion rates by a factor of 5. This in conclusion confirmed the effectiveness of the mechanical cleaning/biocide treatment in mitigating microbial corrosion.

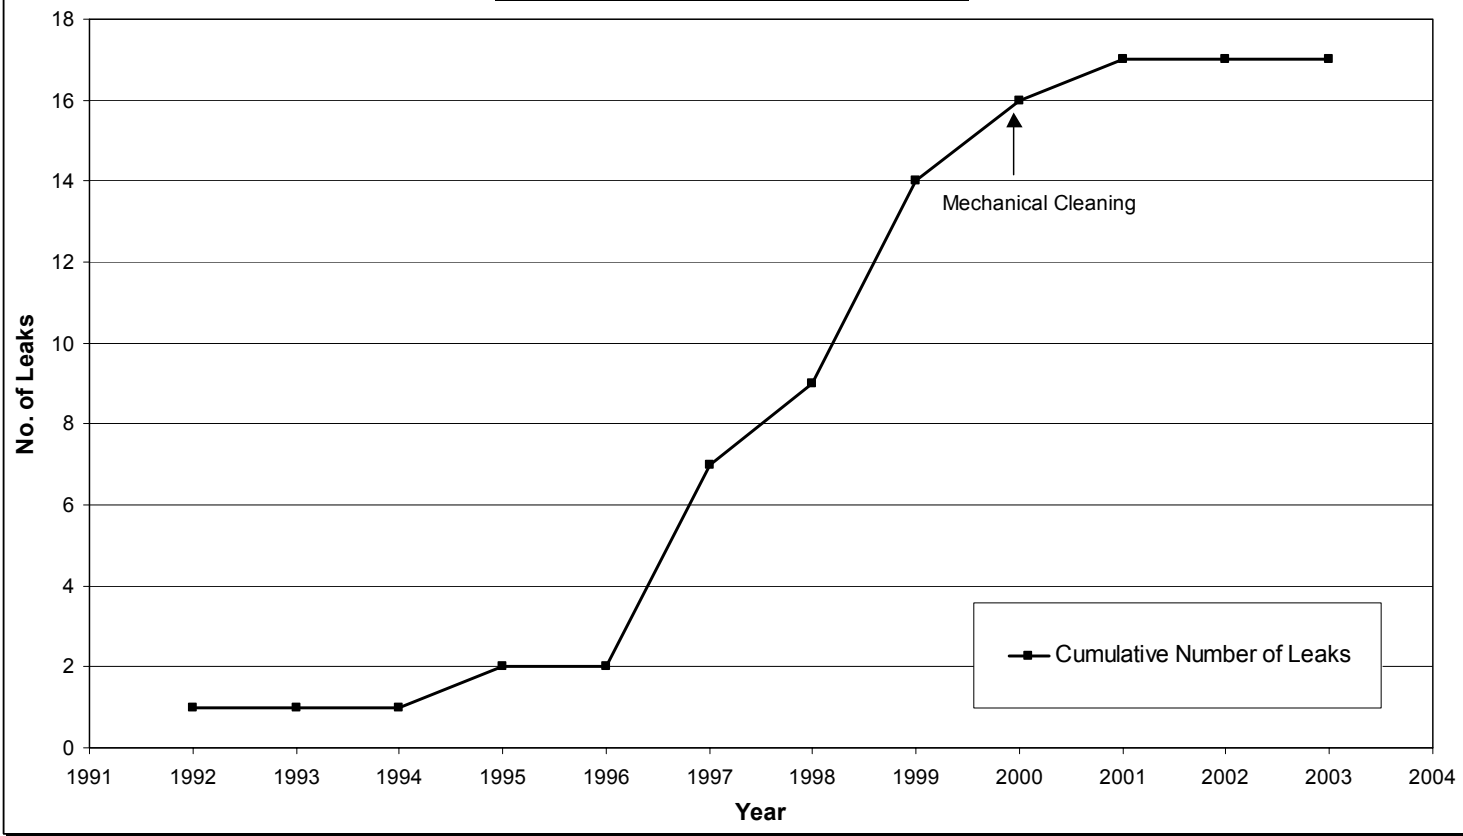
Figure 20

To date, 17 leaks have been experienced in the water injection pipelines of ZAKUM Field (5 lines out of 48). All leaks developed as a result of under-deposit corrosion in the bottom segment due to active SRB. The leak frequency statistics is graphically presented in (Figure 20).
