# **Effect of Aquifer Dumpflood on the Reservoir Scale Tendency and Subsurface Equipment Corrosion**

Abd Elaziz M. Salah Eldin  
Abu Dhabi Marine Operating Company ADMA-OPCO  
Abu Dhabi, United Arab Emirates  
Fax: 971026064771  
E-mail: aaziz2@adma.ae

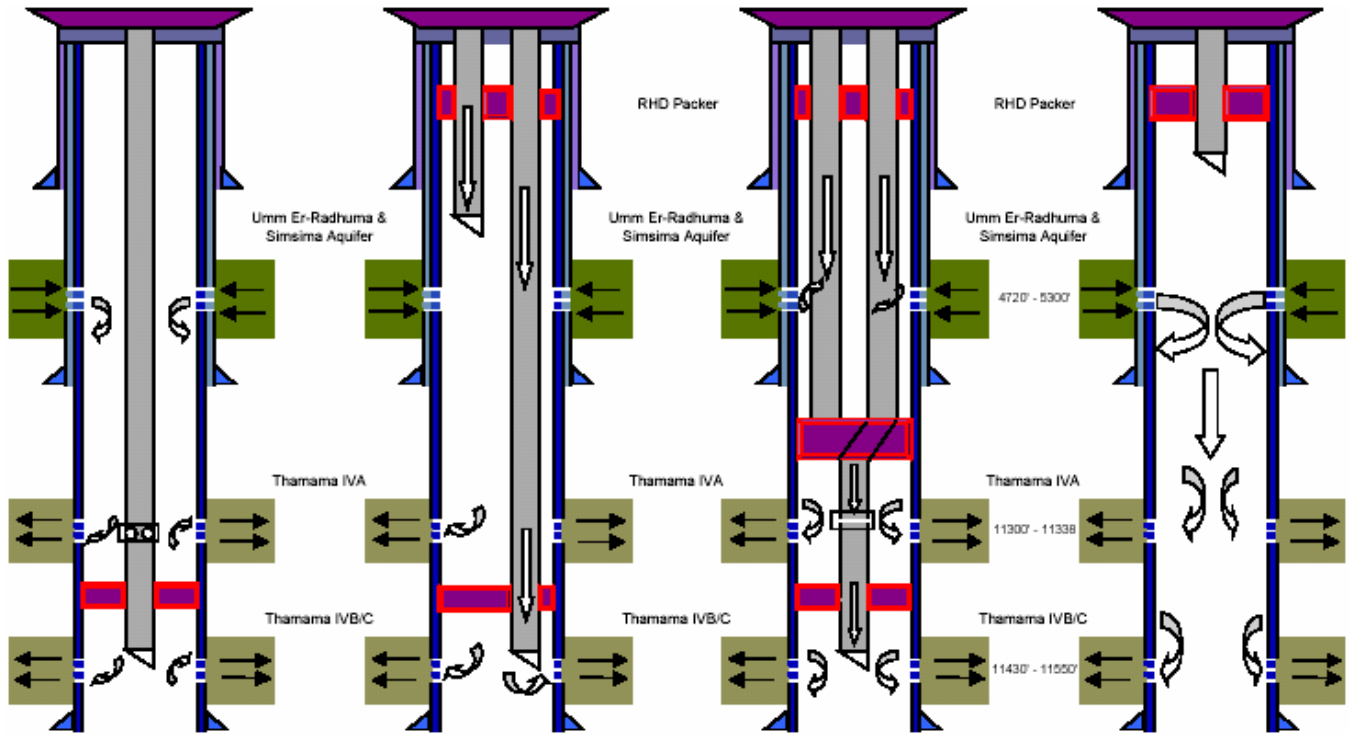
Figure 10 – Different Type of Water Injection Completions & Aquifer Isolation Technique

Figure 9 graphically illustrates the different types of completion used in the water injection wells and aquifer isolation technique.
