**Integrity Management of the Water Injection
Networks in ADMA-OPCO
“A Historical Review of Service Life Events
and its Contribution to the
Experienced Network Failure”**

Abd El Aziz M. Salah
Abu Dhabi Marine Operating Company
Abu Dhabi – United Arab Emirates
E-mail: Aaziz2@adma.co

ZK 145 to ZK 168, 14” water injection line failure was considered as a typical example to investigate the mode of failure and identify the root causes.

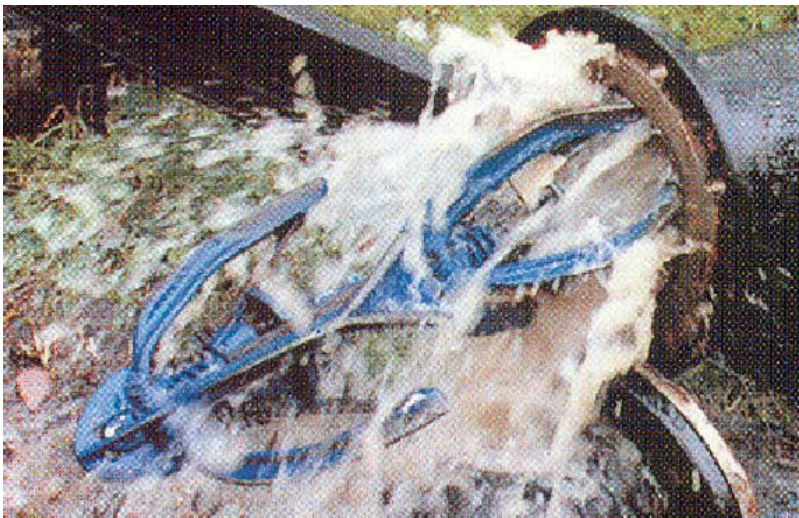
During the 19 years service life of the 14" water injection flowline ZK 145 – ZK 168, the line was cleaned twice while using temporary pig launcher and receiver. The first cleaning was carried out in 1993 using foam & brush pigs while the second was carried out in 1997 where hard mechanical cleaning pigs were considered. Apart from the 1993 & 1997 cleaning campaigns the subject pipeline was never cleaned. Illustrative drawings of the mechanical cleaning pigs are attached as Figure 19.

Figure 19 - Mechanical Cleaning Tools

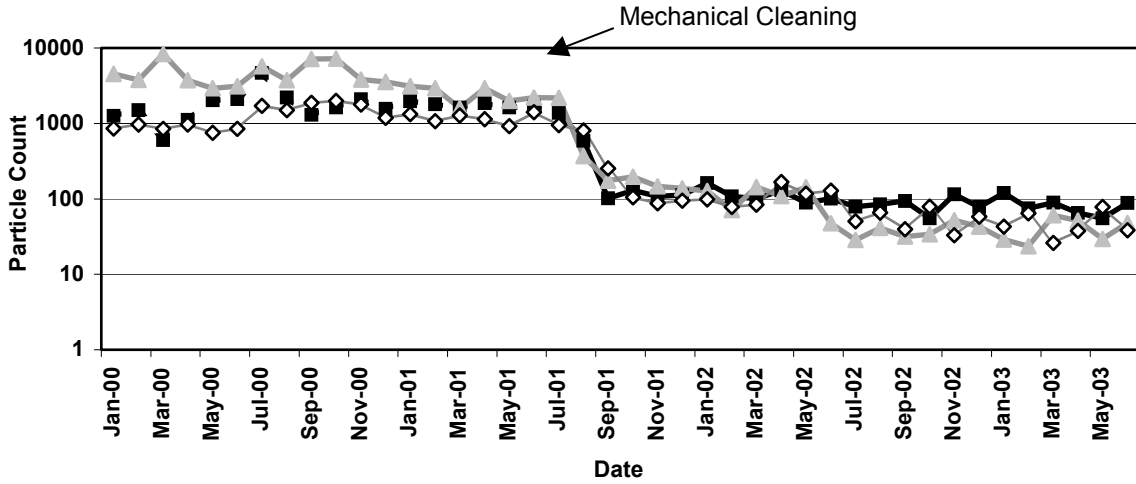
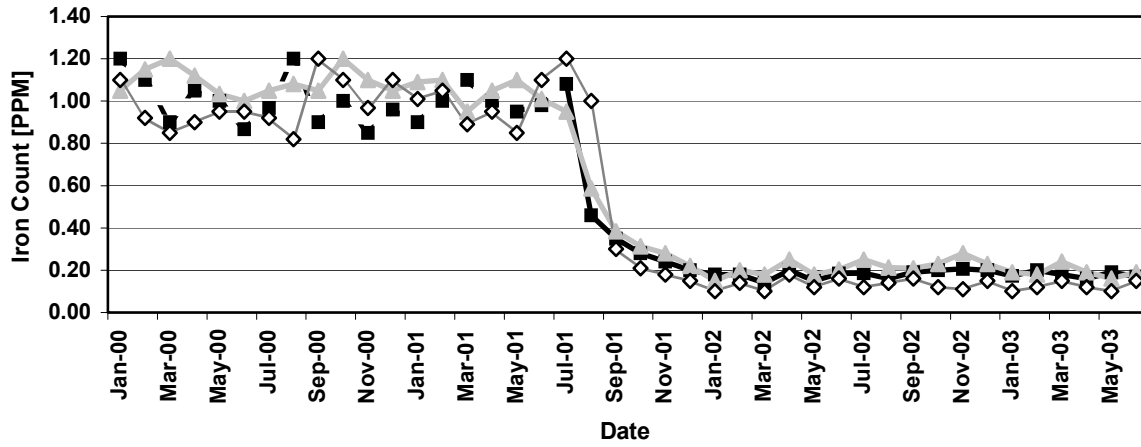
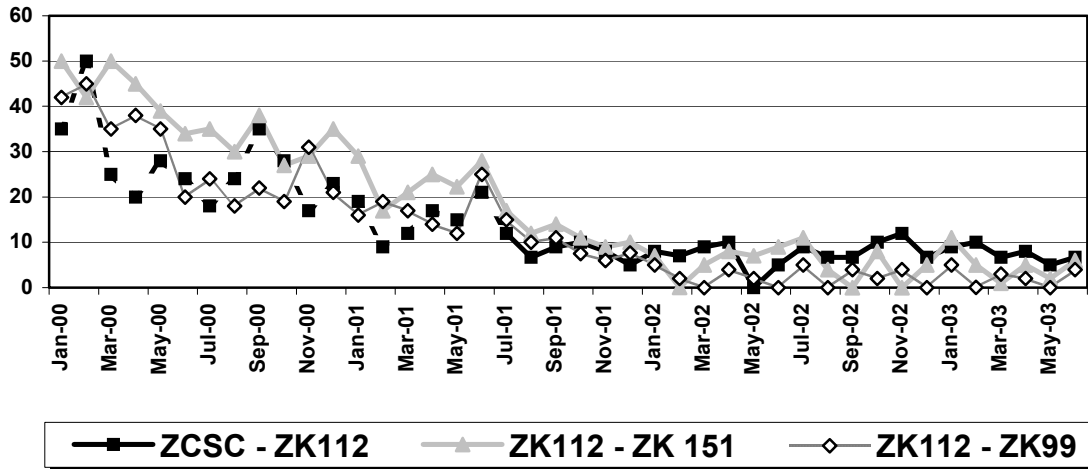
Figure 21

Following mechanical cleaning the iron count dropped from 0.5 - 0.6 down to 0.2 mg/litres and the particle count from an average of 2000 particle / 0.05 ml down to less than 130 partial which exceeds the specification requirements (<200 partial / 0.05 ml). Current compliance of the water injection major traffic light indicators i.e. particle, iron count and bacteria are presented in Figure 21.
